## **Rehabilitation of Fire Sprinkler Systems Affected by Corrosion - The piping dilemma: Wholesale or partial replacement?**

Ockert J. Van Der Schijff, Pr.Eng., Ph.D.  
President

**CorrConsult, LLC**  
55 Constitution Street  
Ashland, MA 01721  
Tel: (617) 320-9111  
Fax: (508) 881-8535

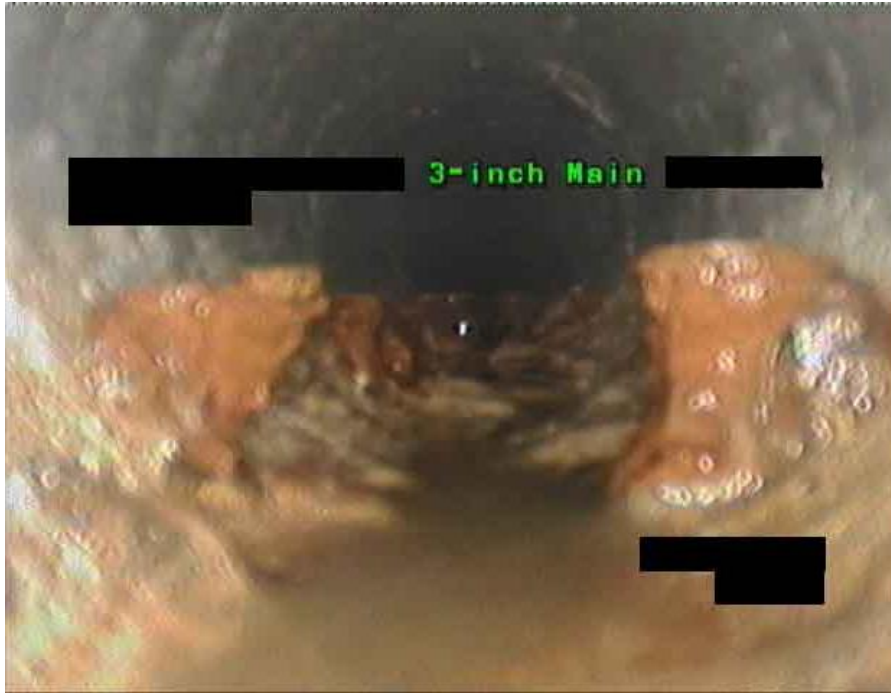
Figure 1 is a screen capture from a video-borescope inspection of a 3" main showing the accumulation of corrosion product deposits below the air/water interface. However, in Figure 2, another section of the same system where there was no residual water shows no significant corrosion damage.

**Figure 1. Video-borescope screen capture from pre-action sprinkler system inspection showing accumulated corrosion product deposits below the air/water interface at approximately the 4 and 8 o'clock locations.**

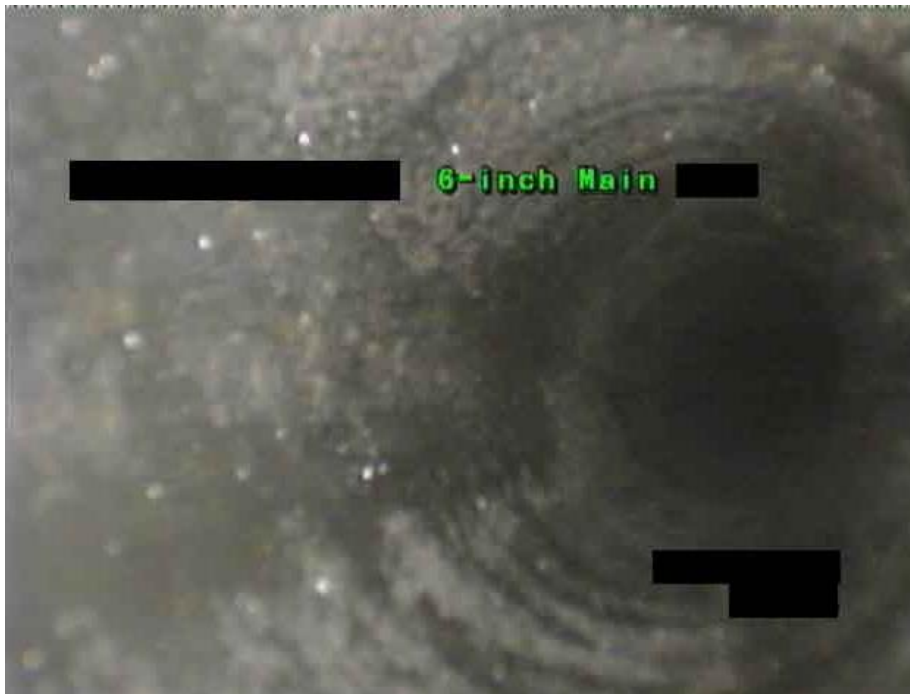
**Figure 2. Video-borescope screen capture showing no corrosion other than normal zinc oxidation in pre-action system without residual water.**

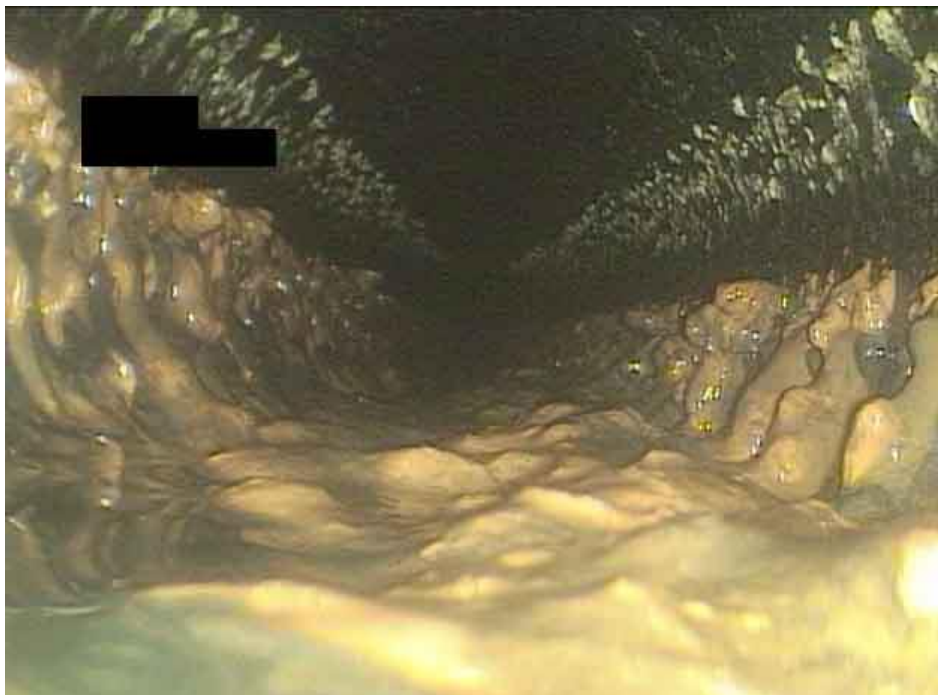
Conversely, in wet sprinkler systems, the corrosion is usually located at high points in the sprinkler piping where trapped air pockets can exist. Trapped air will eventually rise and accumulate at the highest points in a sprinkler system, creating an air/water interface, which results in corrosion damage at the higher elevations in affected systems as shown in Figure 3.

**Figure 3. Video-borescope screen capture from wet sprinkler system inspection showing accumulated corrosion product deposits below the air/water interface at approximately the 3 and 9 o'clock locations.**

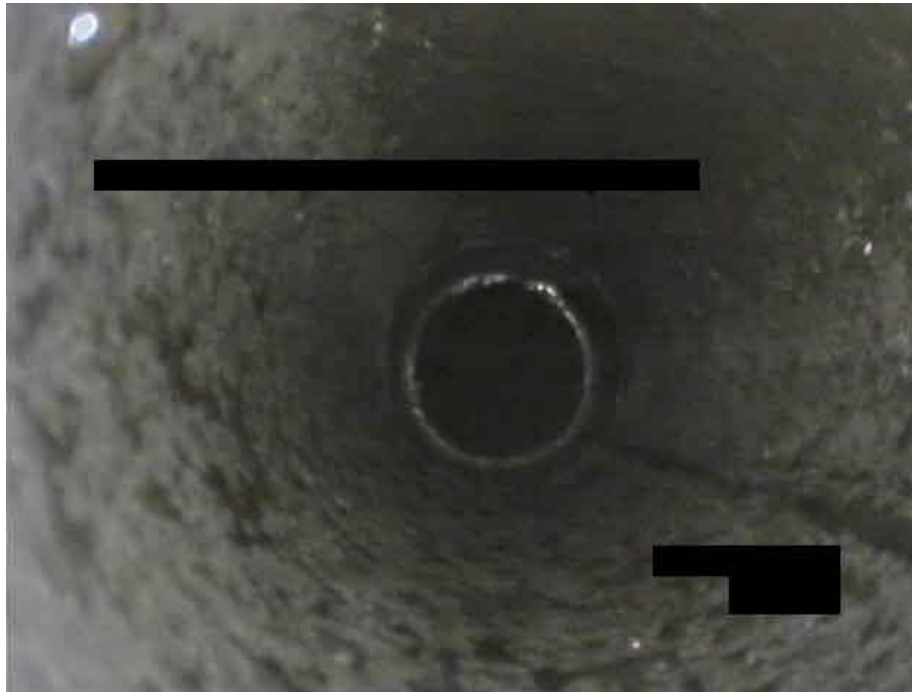
The piping at the lower, water-submerged locations lacks the air/water interface and therefore does not show any corrosion other than the normal layer of black magnetite, which forms as a result of limited uniform corrosion driven by the dissolved oxygen in the charge water.

**Figure 4. Video-borescope screen capture showing no corrosion other than normal zinc oxidation in pre-action system without trapped air.**
